Manhole Inspection Summary

Manhole # S45K__012MH

Insp Date: **7/23/08 11:00 AM**

Location Address: **1801 S Ann St**

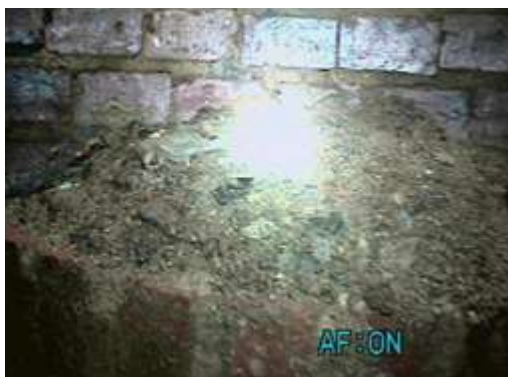
Defect 4

Condition: ☐ Sound ☐ Cracked ☐ Root Intrusion ☐ Deteriorated ☐ Leaks ☒ **Debris**

bench debris

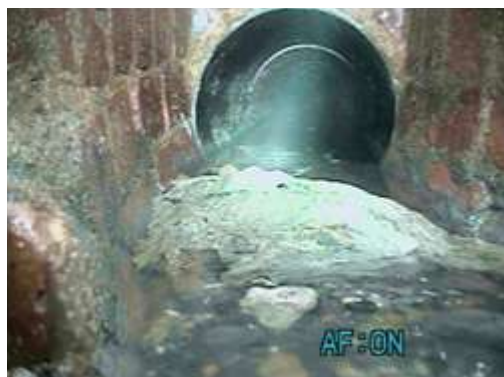
Defect 3

Condition: ☐ Sound ☐ Cracked ☐ Root Intrusion ☐ Deteriorated ☐ Leaks ☒ **Debris**

channel debris

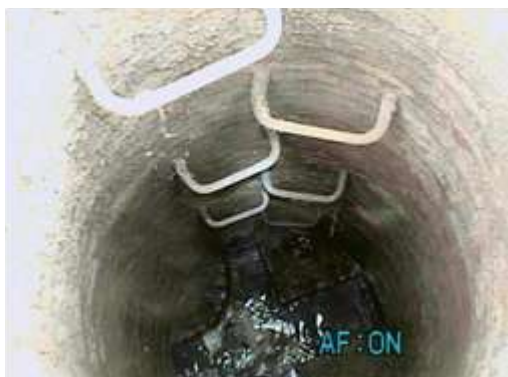
Defect 2

Count: **7** Missing: **0** ☒ **Corroded**

steps

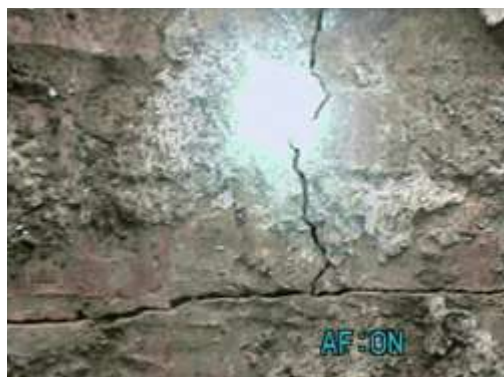
Defect 1

Condition: ☐ Sound ☒ **Cracked** ☐ Root Intrusion ☐ Loose Brick ☐ Deteriorated

crack in corbel

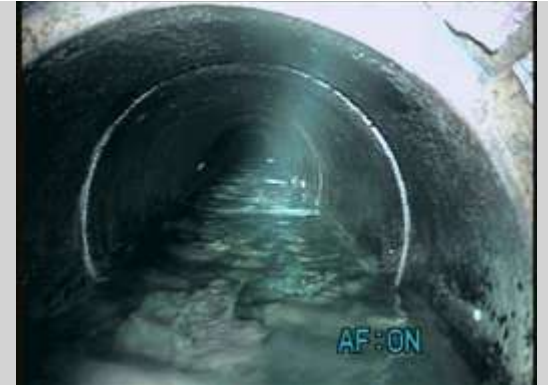
12 O'Clock Outflow

15 in. Circular Gravity Sewer
Pipe Out @ 12 O'Clock

Pipe Material: **Clay** ☐ Pipe Lined

Invert Depth: **10.60** (ft.) Flow Characteristics: **Fast**

Deposits: ☒ None ☐ Mud ☐ Sludge ☐ Debris ☐ Grease

Infiltration: **None** Pipe Seal Cond: **Unknown**

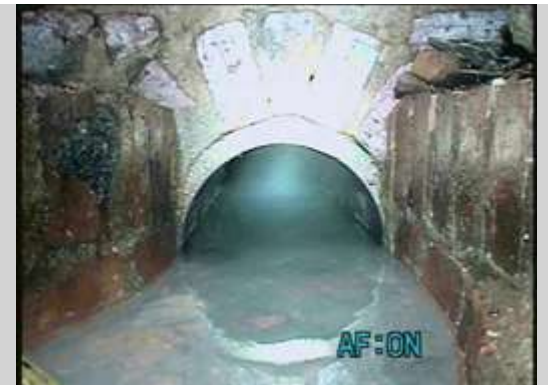
3 O'Clock Inflow

8 in. Circular Gravity Sewer
Pipe In @ 3 O'Clock

Pipe Material: **Clay** ☐ Pipe Lined

Invert Depth: **10.41** (ft.) Flow Characteristics: **Fast**

Deposits: ☒ None ☐ Mud ☐ Sludge ☐ Debris ☐ Grease

Infiltration: **None** Pipe Seal Cond: **Unknown**

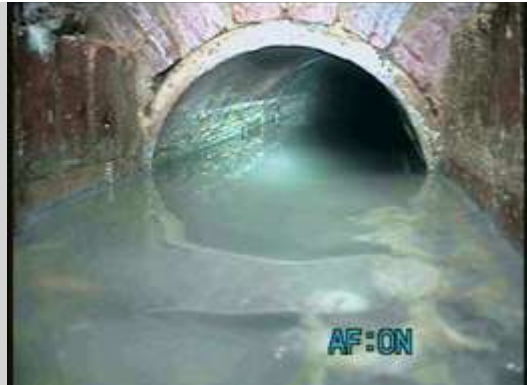
6 O'Clock Inflow

12 in. Circular Gravity Sewer
Pipe In @ 6 O'Clock

Pipe Material: **Clay** ☐ Pipe Lined

Invert Depth: **10.41** (ft.) Flow Characteristics: **Fast**

Deposits: ☒ None ☐ Mud ☐ Sludge ☐ Debris ☐ Grease

Infiltration: **None** Pipe Seal Cond: **Unknown**

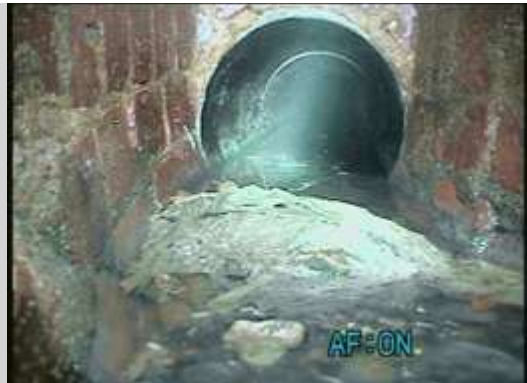
9 O'Clock Inflow

8 in. Circular Gravity Sewer
Pipe In @ 9 O'Clock

Pipe Material: **Clay** ☐ Pipe Lined

Invert Depth: **10.40** (ft.) Flow Characteristics: **Fast**

Deposits: ☒ None ☐ Mud ☐ Sludge ☐ Debris ☐ Grease

Infiltration: **None** Pipe Seal Cond: **Unknown**
